Roller Compacted Concrete Pavements— A Study of Long Term Performance

By Robert W. Piggott, P.E.

March, 1999

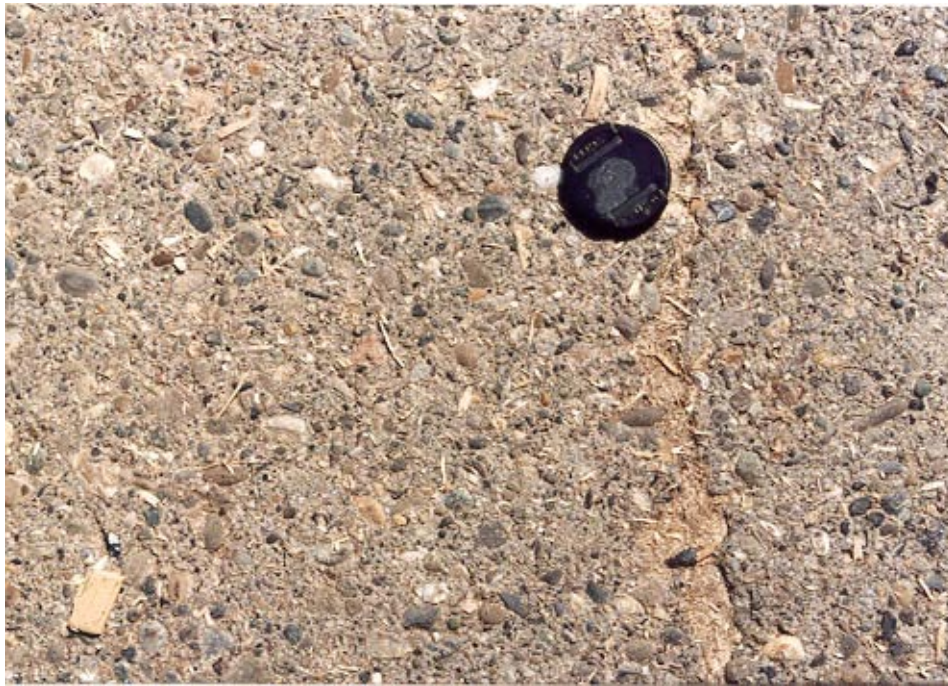
When an RCC pavement is completed and cured, a thin layer of fine aggregate and cement paste remains at the surface. With abrasion from traffic and exposure to weathering, some of this fine surface material is worn away in the first 2-3 years of service. However, the loss of these fines to a depth of no more than 2 mm (1/16 in.) seems to be the extent of surface erosion for most of the projects that were studied, regardless of the age of the pavement. There is a remarkable similarity in surface appearance of pavements that are five years old to those that have been in service for ten years or more. The coarse aggregate at the surface remains firmly embedded in the RCC matrix. (Figs. 2 & 3)

Figure 2 Surface at Fibreco Pulp Inc, Taylor, B.C. Built in 1988.

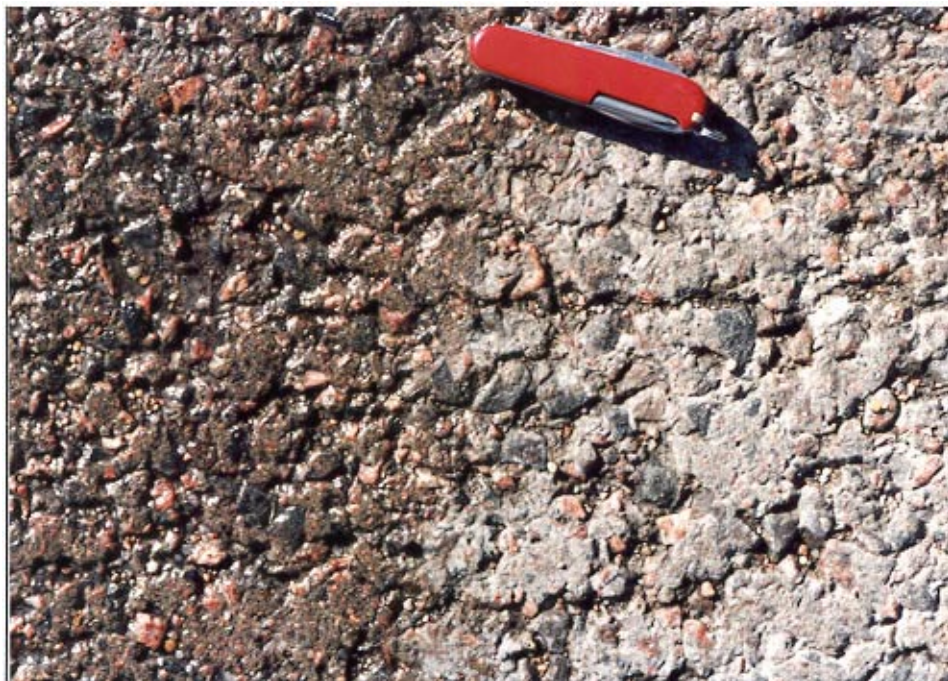
Figure 3 Surface of intermodal terminal, Denver, CO. Burlington Northern Santa Fe. Built in 1985.

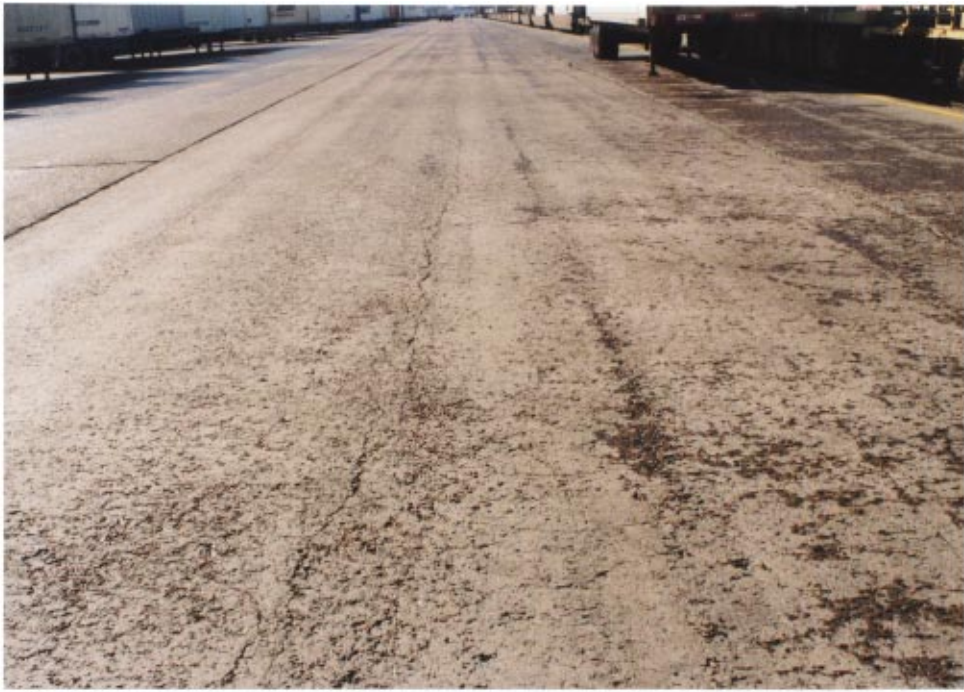
Where unsurfaced RCC has been used for intermodal terminals (Boston, Denver), patches of surface erosion are more extensive. Material loss to a depth of 8 mm (3/8 in.) was observed in some areas. It is important to note, however, that this condition usually occurs in patches of variable size from 1 to 9 m² (10 to 100 ft²), while nearby a section of RCC surface may show a "nearly new" appearance. (Fig. 4)

Figure 4 Variation in surface texture, intermodal terminal, Denver, CO Burlington Northern Santa Fe. Built in 1985. (*Dark areas are surface moisture*)

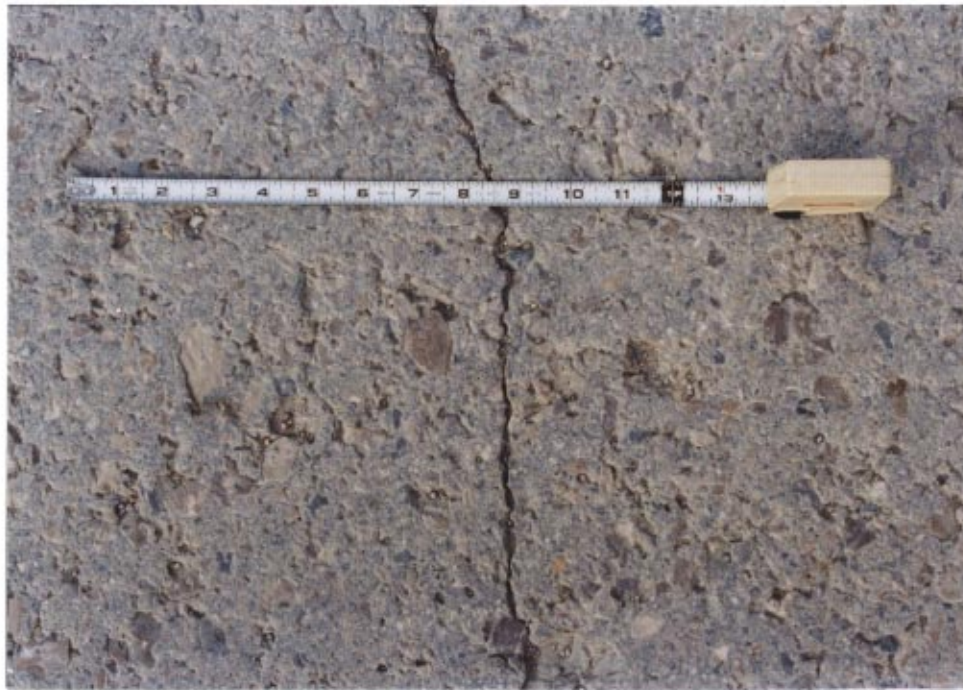
Figure 5 A typical shrinkage crack. GM Saturn plant, Spring Hill TN. Built in 1988.

Saw cut shrinkage control joints were installed on portions of four of the road pavements - 112th Ave., Edmonton, Fort Drum, NY, and Bighorn Ave., Alliance, NE. and the Saturn plant roads at Spring Hill, Tenn. At spacing in the range of 6 m to 9 m (20 ft. to 30 ft.), transverse shrinkage was almost completely controlled by the saw cuts. Bituminous crack filler was used on all the joints on Bighorn Ave. Crack sealing was also observed on some of the joints at Fort Drum and the Saturn plant pavements. No sealer was observed at 112th Ave. While sealing of joints (random or saw cut) may reduce joint edge chipping, most of the unsealed joints were also in very good condition. (Fig. 5)

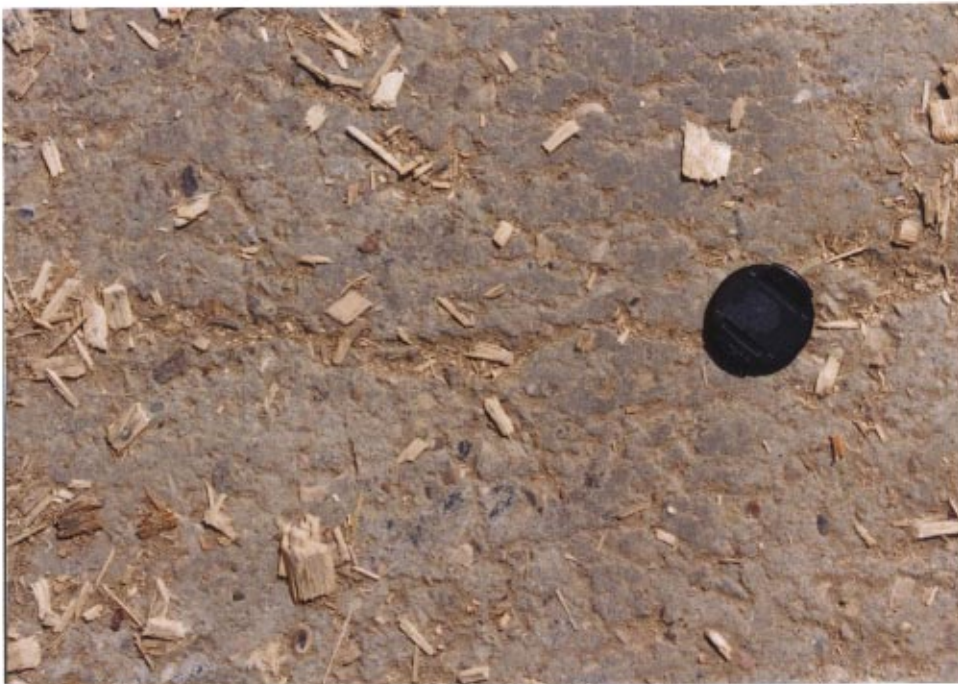
The usual answer from operators to questions about crack maintenance was that there have been no problems with the cracks in the RCC pavement, hence no need for any maintenance! Usually debris from the surface filled the cracks - fine aggregate, wood debris, coal dust, etc. (Fig. 6) In the colder climates with unsurfaced RCC pavement, there is occasional evidence of edge chipping from larger stones that become embedded in the cracks that opened up in winter. (Fig. 7) None of those interviewed indicated this to be a serious problem. Most of the cracks observed were tight and it would have been difficult to achieve penetration of the sealant in any case. (See Fig. 5) While there is minor erosion of the crack edges at the surface, at a depth of 6 mm (1/4 in.) crack width is less than 2 mm (1/16 in.) in most cases.

Figure 6 Wood fibre in the shrinkage crack. Alberta Pacific Forest Industries, Athabaska, AB. Built in 1992.

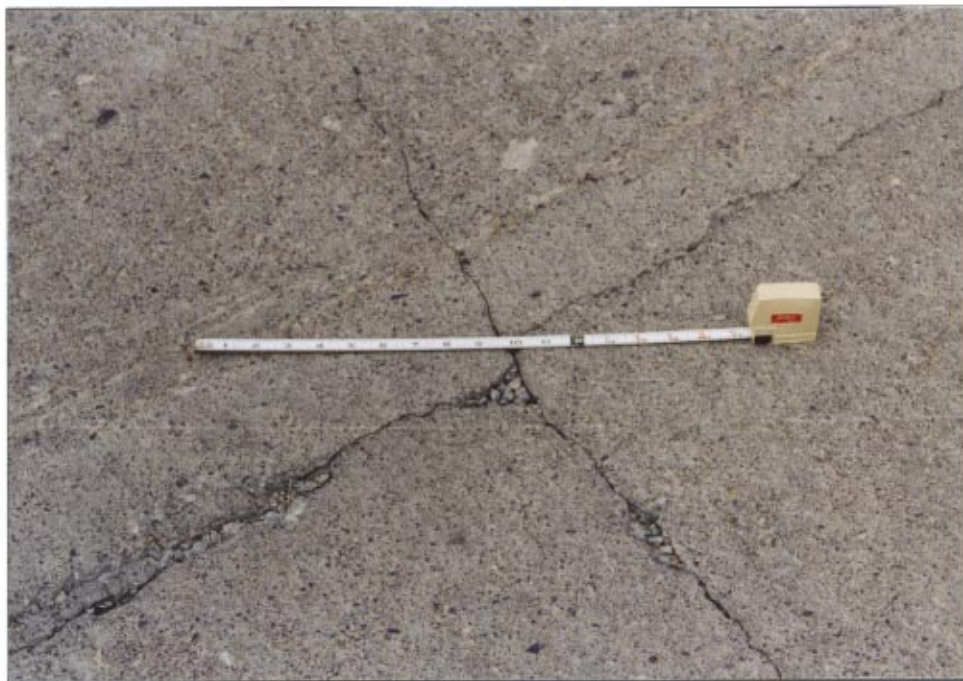
Figure 7 Chipping at the edge of shrinkage cracks from incompressible debris that enters the crack in winter. Fort Drum, NY. Built in 1988.

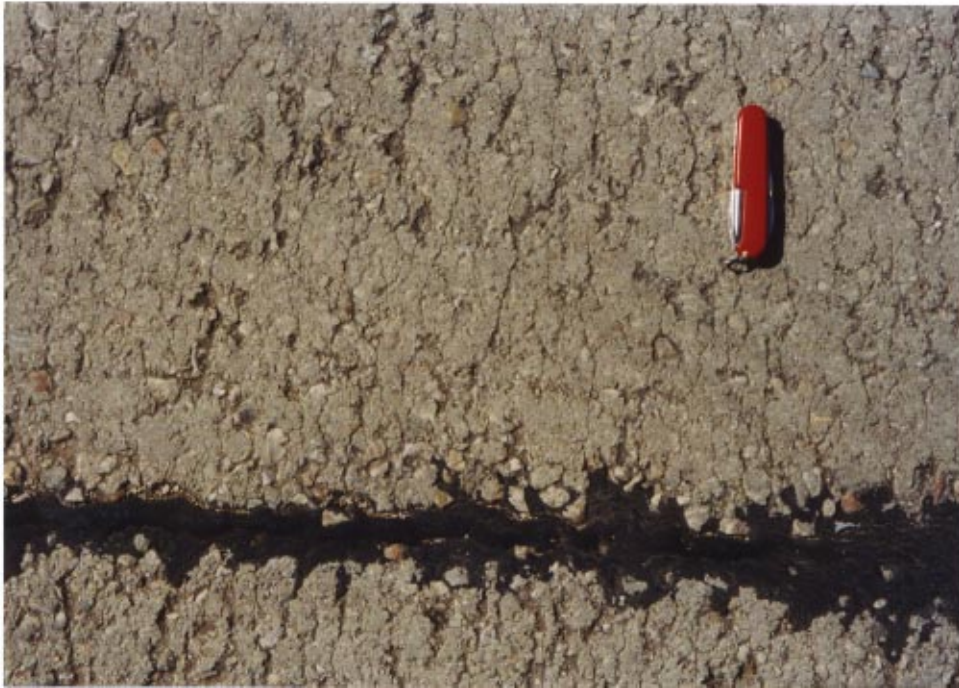
Figure 8 Joints were routed and sealed 12 months after construction was completed. Central Freight Inc., Austin, TX. Built in 1987.

On those few projects where a crack sealing program has been implemented, hot poured asphaltic sealant was usually the material of choice. At the Central Freight Inc. truck terminal at Austin, TX, a “route and seal” program was carried out 5 years after construction was completed. (Fig. 8.)

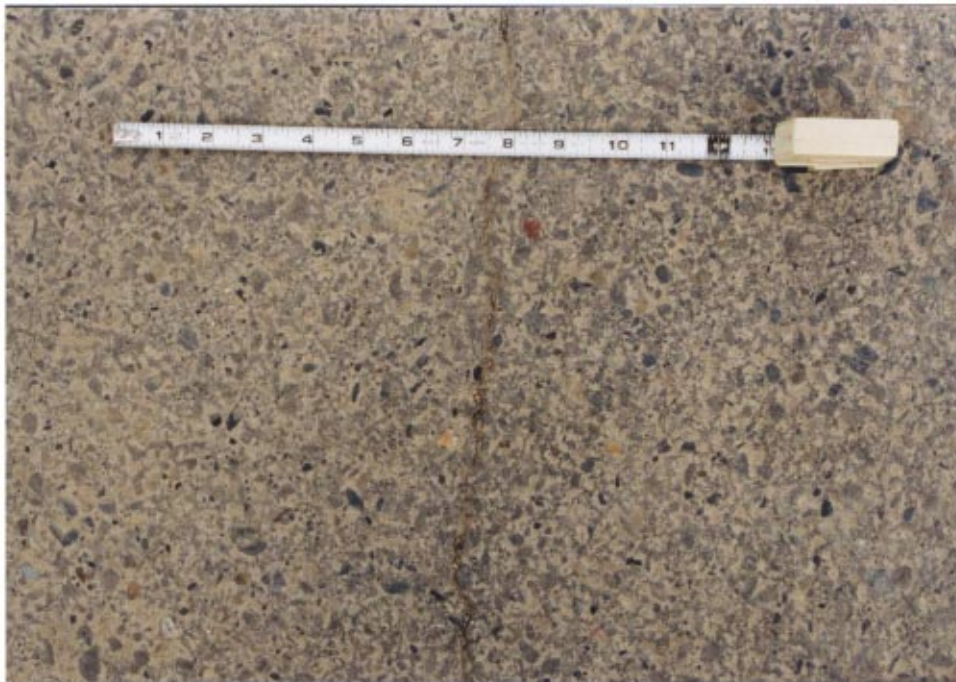
Where an RCC pavement was overlaid with asphalt (Fig. 9), original shrinkage cracks in the RCC reflected through the asphalt overlay. Intentional delay of several weeks or months before applying the asphalt layer resulted in the reflection cracks being almost hairline in appearance.

Figure 9 Reflection crack through 50 mm (2 in.) asphalt overlay. Fort St. John, B.C. Built in 1995.

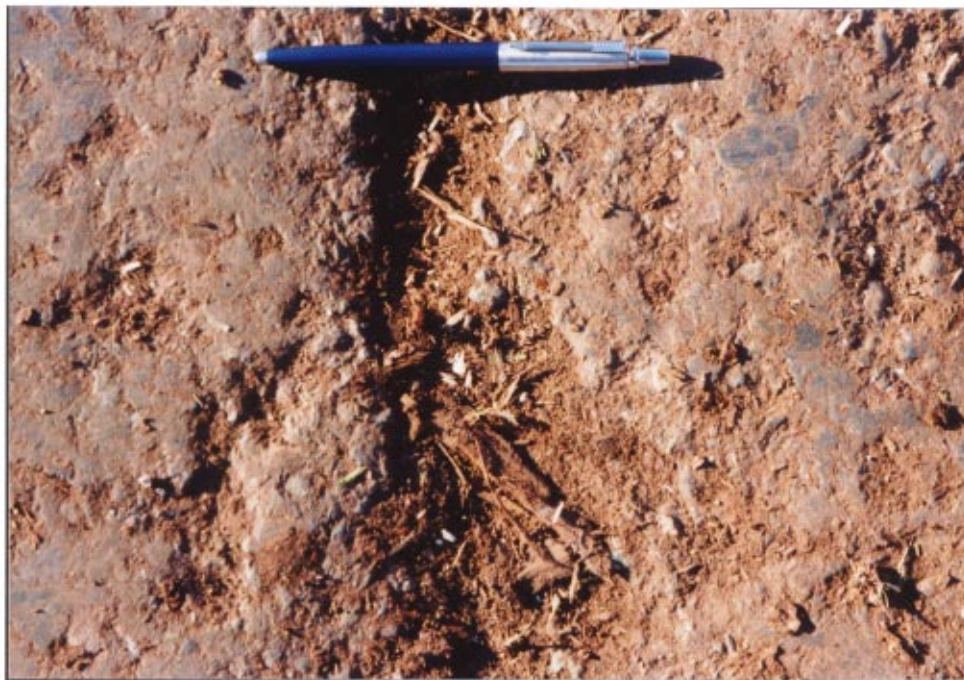
Longitudinal cracking approximating the width of the paving lane was observed on nearly all pavements studied. The most serious deterioration usually occurs at these longitudinal joints, especially if they were also “cold joints” (ones that remained over night during construction). Maintenance and repair was varied. Some owners installed a partial depth cementitious patch, ranging in width from 200 mm to 600 mm (8 in. to 24 in.) wide, and 100 mm to 250 mm (4 in. to 10 in.) deep, depending on the original thickness of the pavement and the extent of the deterioration. Others patched the eroded area with asphalt, epoxy compounds or a variety of other materials. If the deteriorated joint did not hamper the operation of the facility, many owners did nothing at all by way of repair. (Fig. 10)

The lack of any faulting is particularly interesting at the Port McNeill log sorting yard operated by MacMillan Bloedel Limited on Vancouver Island, British Columbia. This 300 mm (12 in.) thick pavement was built in 1978 and has been in continuous service since then. Cracking is extensive with spacing as close as 3 m (10 ft.) in some parts of the surface. Other than patching some of the cold joints, there has been very little joint maintenance done. (Fig. 10 & 11)

Figure 10 A 20 year old shrinkage crack, MacMillan Bloedel Ltd. log sorting yard, Port McNeill, Vancouver Island, B.C.

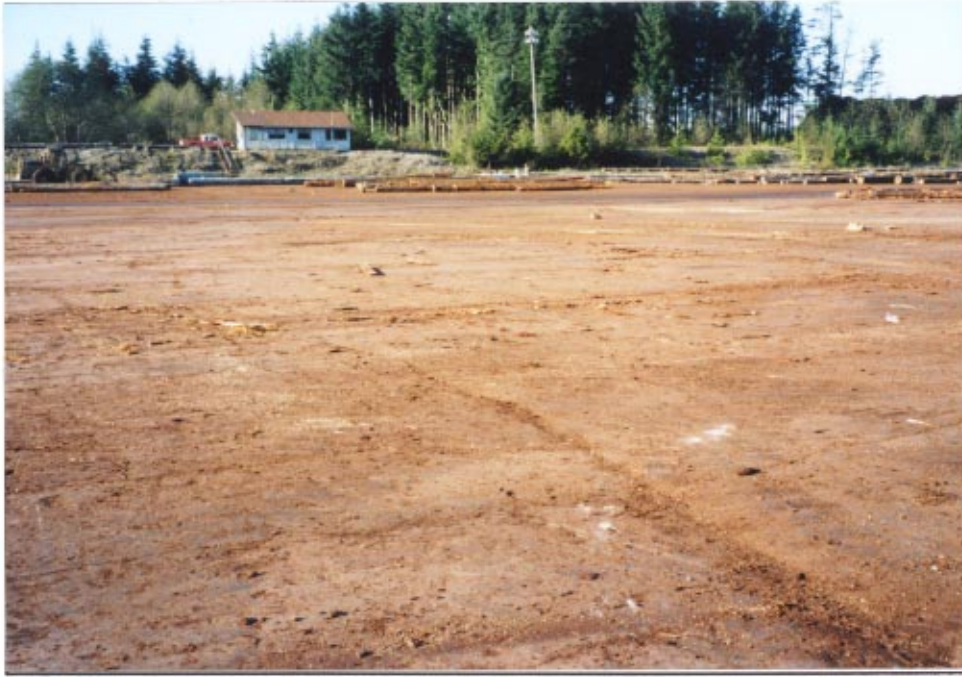
Figure 11 MacMillan Bloedel Ltd. log sorting yard, Port McNeill, Vancouver Island. No faulting at the numerous cracks in the surface. Built in 1978.

The Vancouver Island log sorting area operated by MacMillan Bloedel Ltd. is an good example of an RCC pavement that has been in continuous service for over twenty years and now exhibits extensive cracking (Figure 11). The cracking has had minimal effect on the operation of the log sorting yard and the pavement is still performing its original function. The operators report continued satisfaction with the RCC pavement.

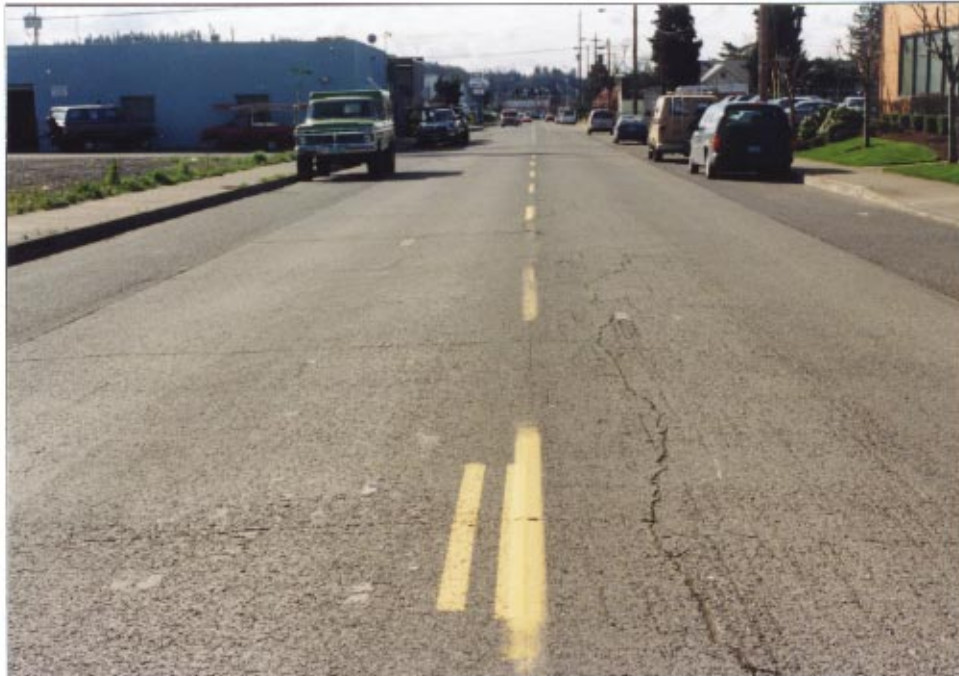
The pavement on 99th Ave. in Portland, OR, is an excellent example of exposed RCC performance in an urban environment. The pavement was built in 1986 and carries commercial and bus traffic. Very little material has been eroded from the surface and the joints remain tight. There is no evidence of crack sealing. (Fig. 12)

Figure 12 Collector class road, 99th Ave., Portland, OR. This exposed RCC pavement was built in 1986. The parking lanes on each side are asphalt pavement.

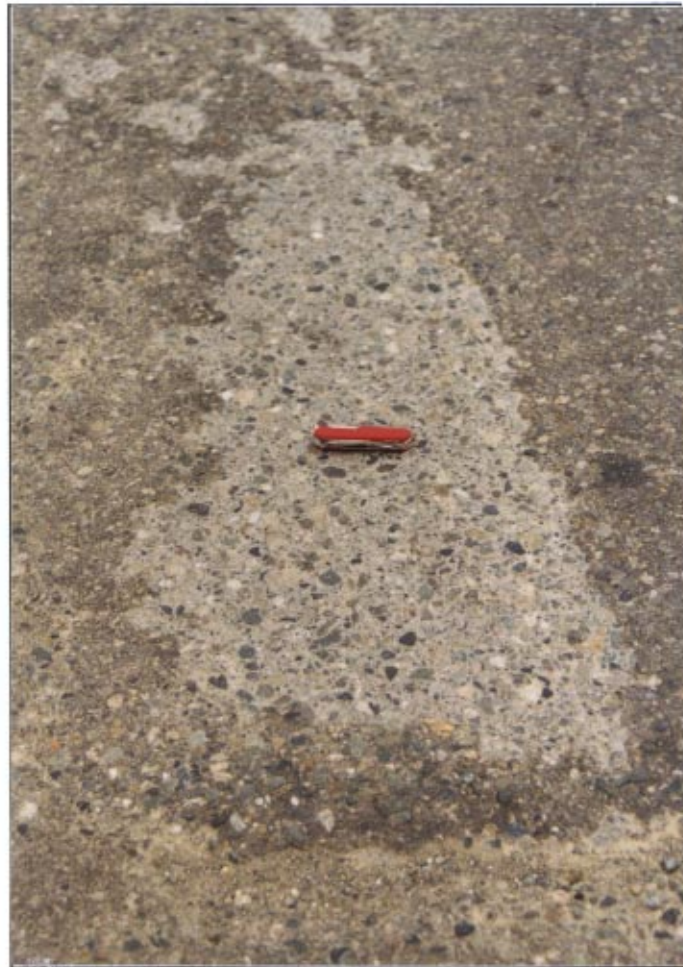
The pavement on Likely Rd. near Williams Lake, B.C. is one of the best examples of RCC wear and durability in a winter climate. The pavement was built in 1987, however, within three years part of the original chip seal surface was worn away under heavy braking of logging trucks, leaving the RCC exposed. Though exposed to salt and sand through several winters, the surface was unaffected. In 1995 the RCC pavement was cover again, this time with 25 mm (1 in.) of asphalt. In 1998 that overlay is beginning to wear off once more, exposing the RCC base to traffic wear, sand and deicer salts for a second time. (Fig. 14)

Figure 14 RCC is once again exposed on Likely Rd., Williams Lake, B.C. Built in 1987.

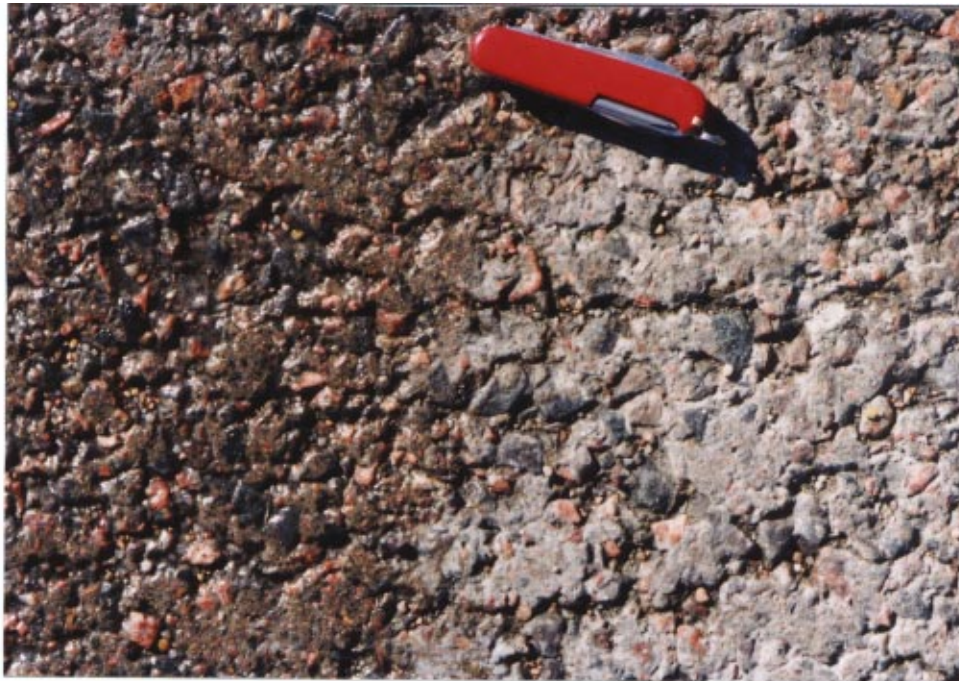
As with most of the RCC pavements studied, transverse shrinkage crack spacing is highly variable, a few are as close as 6 m (20 ft.), with the occasional crack at 30 m (100 ft.) away from the next. Most are tight, though minor edge breakdown is beginning to show up in a few areas. According to the terminal manager, very little regular maintenance is done. Longitudinal joints are showing more deterioration with edge breakdown widening some sections to 100 mm (4 in.). There is no settlement (faulting) across any of the shrinkage cracks or longitudinal joints. One panel approximately 4.5 m (15 ft.) square has lifted about 75 mm (3 in.) at one corner. There is no obvious explanation for this occurrence.

Figure 16 Closeup of the RCC surface. Built 1986.

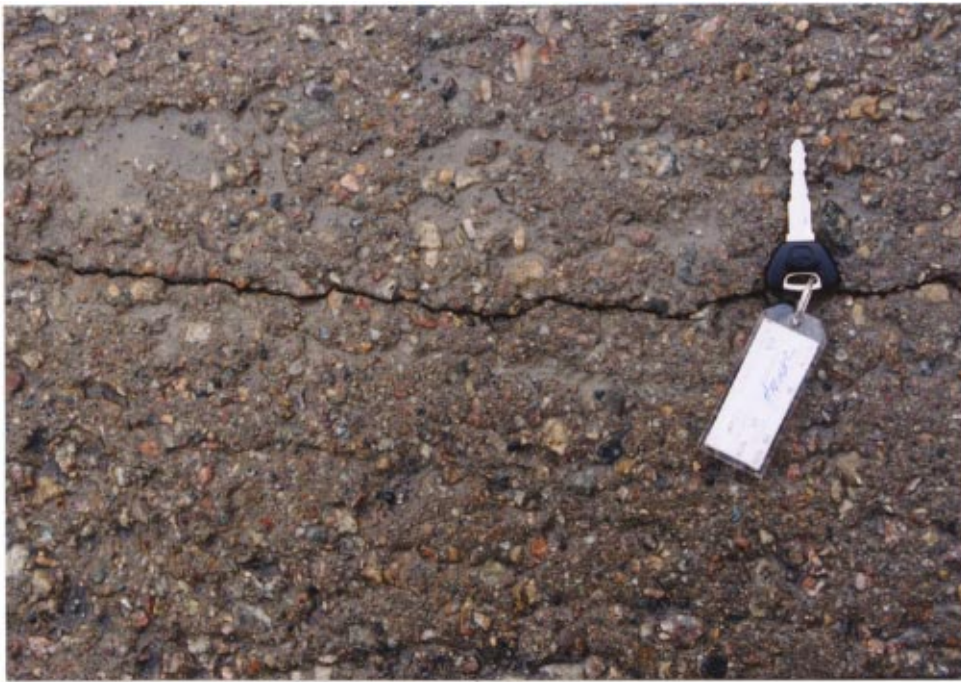
Away from longitudinal construction joints and the transverse shrinkage cracks, the RCC surface shows only minor erosion to a maximum depth of approximately 6 mm (¼ in.) in some areas. The surface erosion is not uniform over the entire pavement however. At least 75% of the paved surface exhibits the typical loss of fine material that was observed on nearly every RCC pavement inspected in this study.

Figure 18 Typical condition of the RCC surface at Conley Terminal, Boston, MA

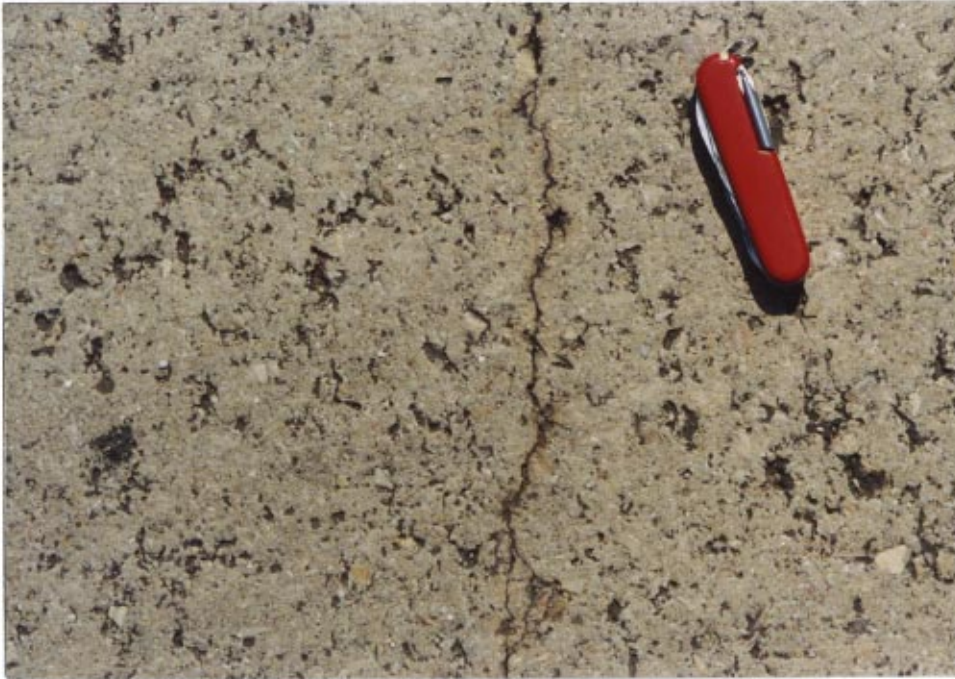
Figure 20 Shrinkage crack and surface condition, Central Freight Terminal, Austin, TX. Built in 1987.

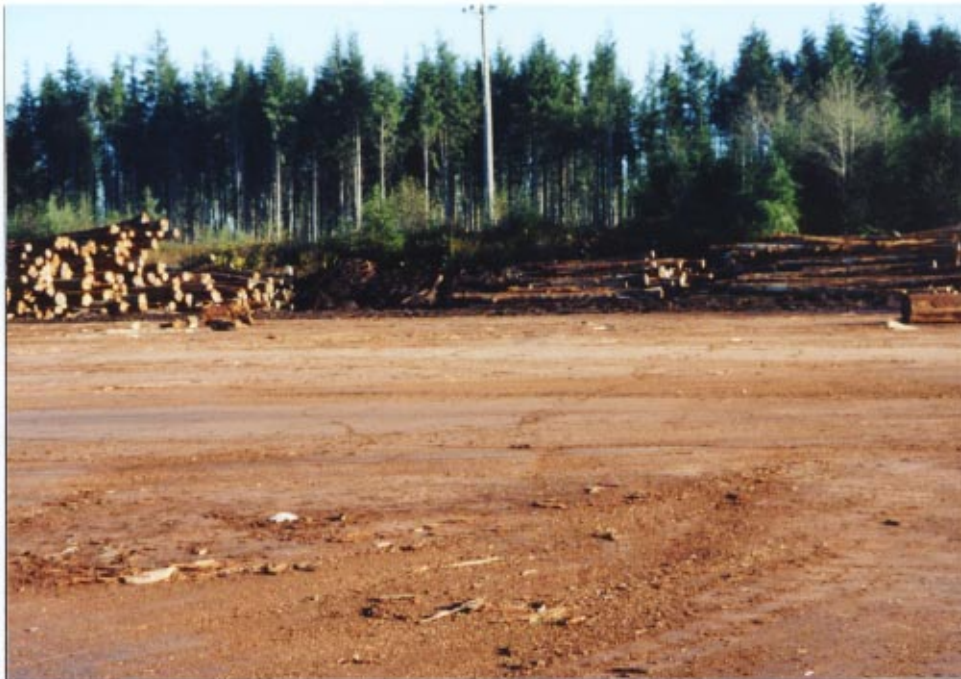
Figure 24 Though cracking of the surface is extensive, the log sorting yard continues in full operation after 20 years.

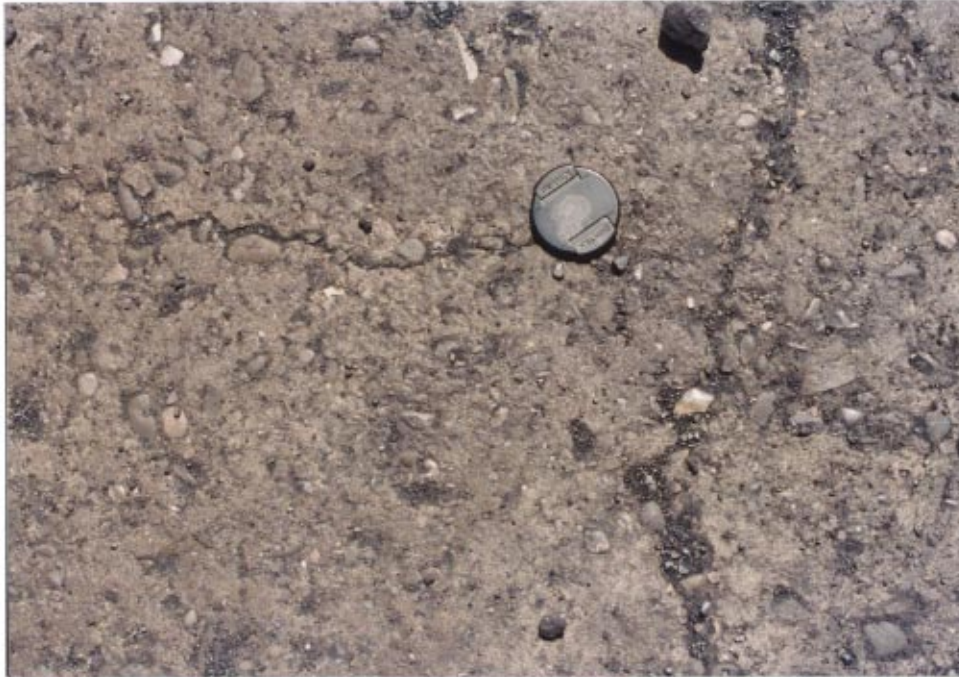
Other than the typical loss of fines from the top 2 mm (1/16 in.), there is no distress in the pavement. Maximum aggregate size is 31 mm (1¼ in.). Shrinkage crack spacing is variable, averaging 10 m (35 ft.). No crack sealing has been done, though most of the cracks are filled with coal fines. No faulting has occurred at the shrinkage cracks after 16 years of service. The pavement is in excellent condition.

Figure 26 Shrinkage cracks become filled with coal dust.

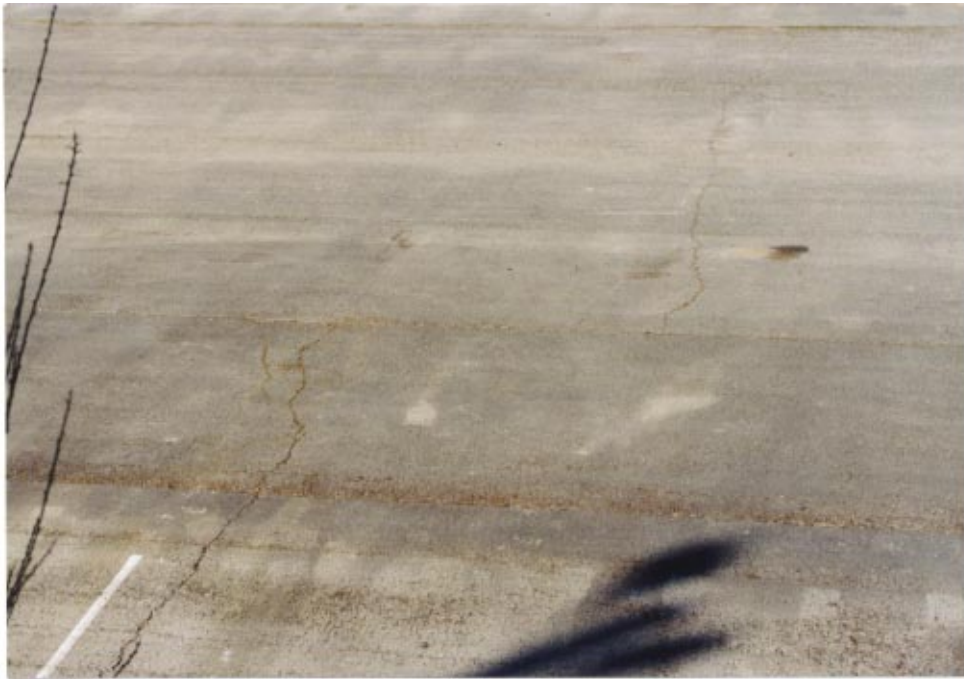
The usual shrinkage cracking pattern has developed, however no joint sealing has been done. The pavement is in very good condition although it does not appear to be subjected to much heavy loading.

Figure 28 Typical shrinkage cracking pattern at Fort Lewis, WA.

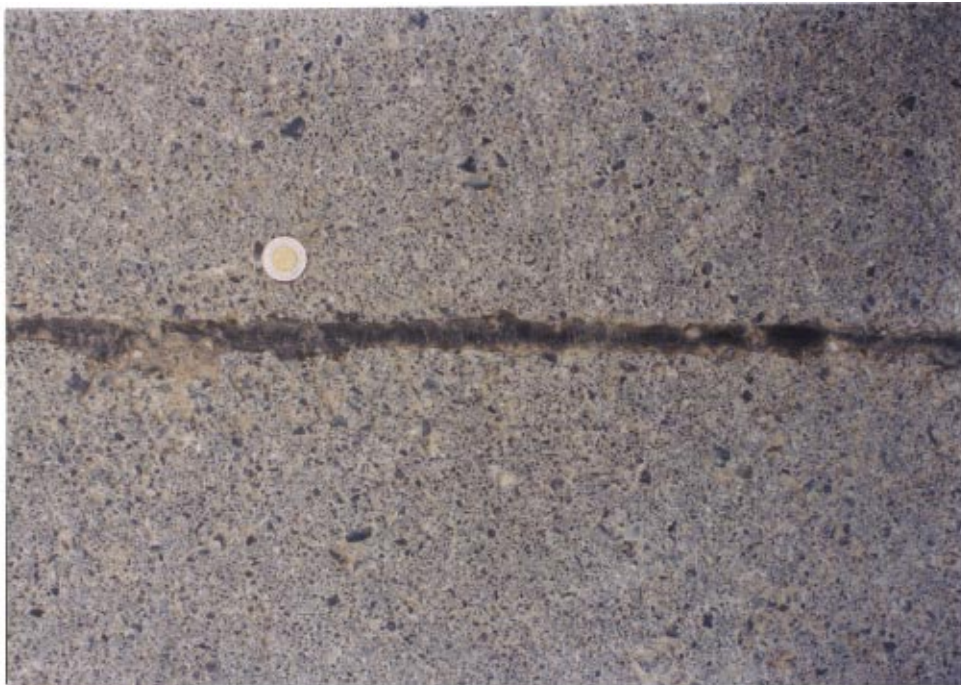
Figure 30 Bituminous joint sealant at a shrinkage crack.

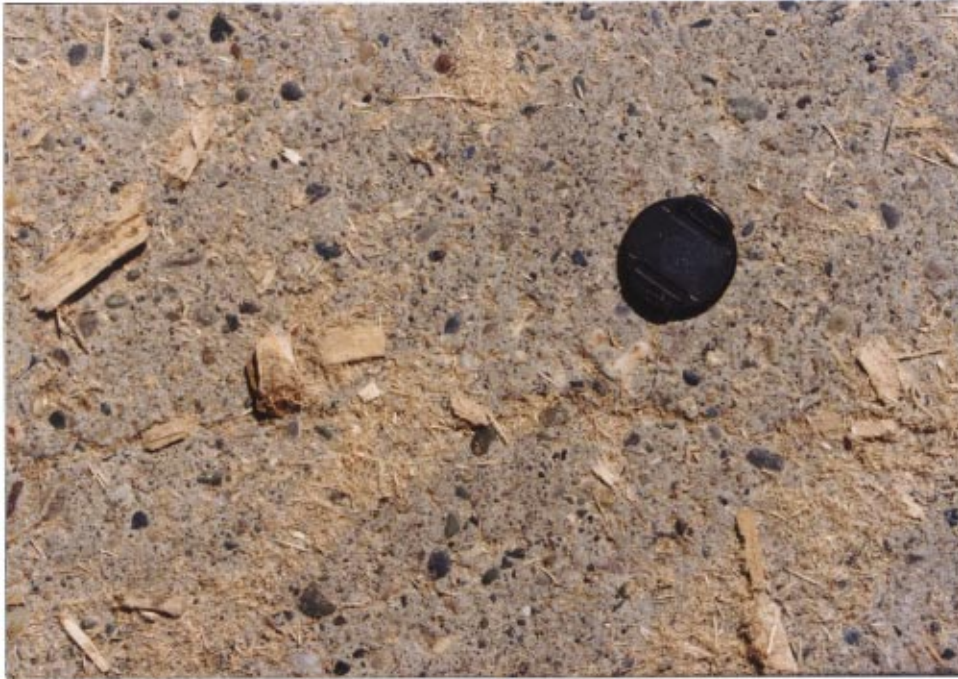
Shrinkage cracks remain tight with only minor edge breaking at the surface to a maximum width of 6 mm (¼ in.). Spacing of the cracks averages 9 m (30 ft.). No joint sealing or other maintenance has been done. Wood debris from the chips fills all of the cracks.

Figure 32 Shrinkage cracks remain tight. Debris from the wood chips fills any space.

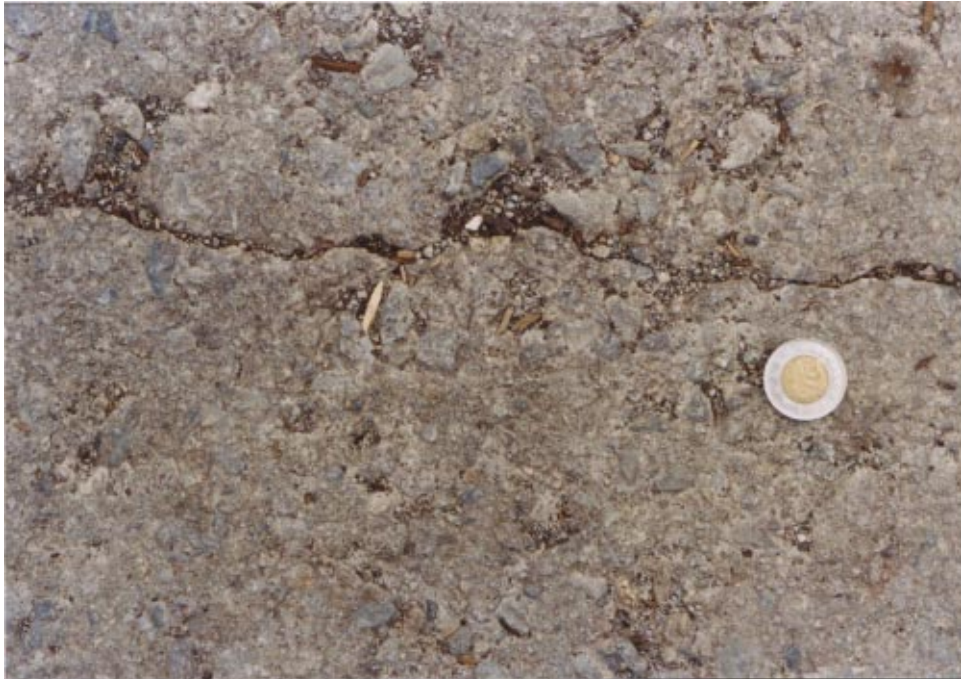
Figure 34 Typical RCC crack showing little deterioration. Joint sealer would be difficult to apply.

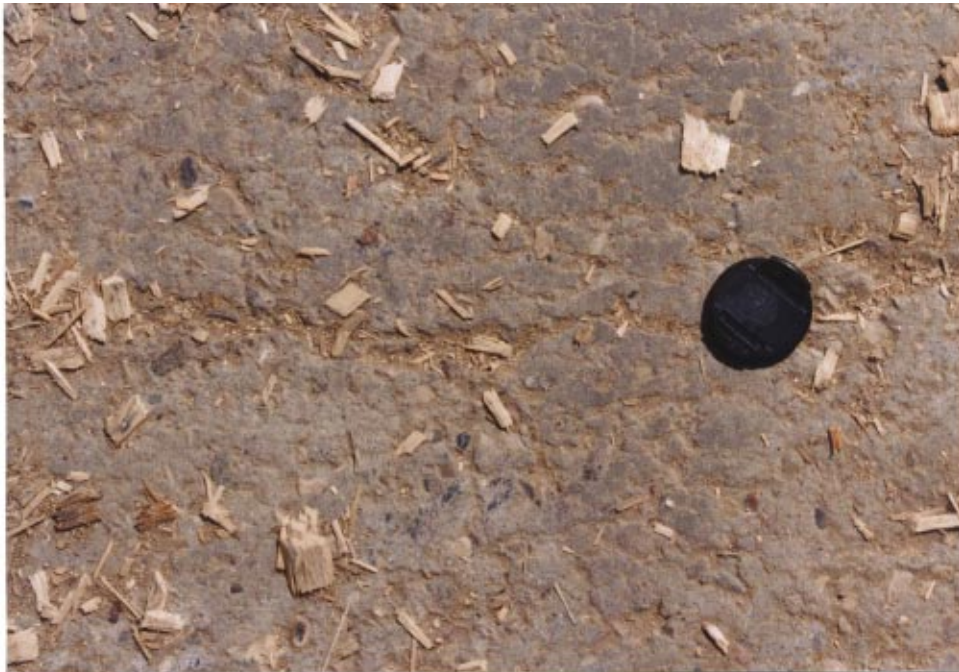
Spacing of transverse shrinkage cracks averages 18 to 20 m (60 to 65 ft.). Crack width at the surface averages 6 mm (1/4 in.) though the cracks are only hairline a few millimeters below the surface. Both the transverse shrinkage cracks and construction joints are tight and filled with wood debris. No crack maintenance whatsoever has been done since initial construction. Load transfer across all cracks appears to be excellent since there is no evidence of faulting anywhere.

Figure 36 Wood debris fills the shrinkage cracks. The company finds no need to carry out any maintenance on the cracks.

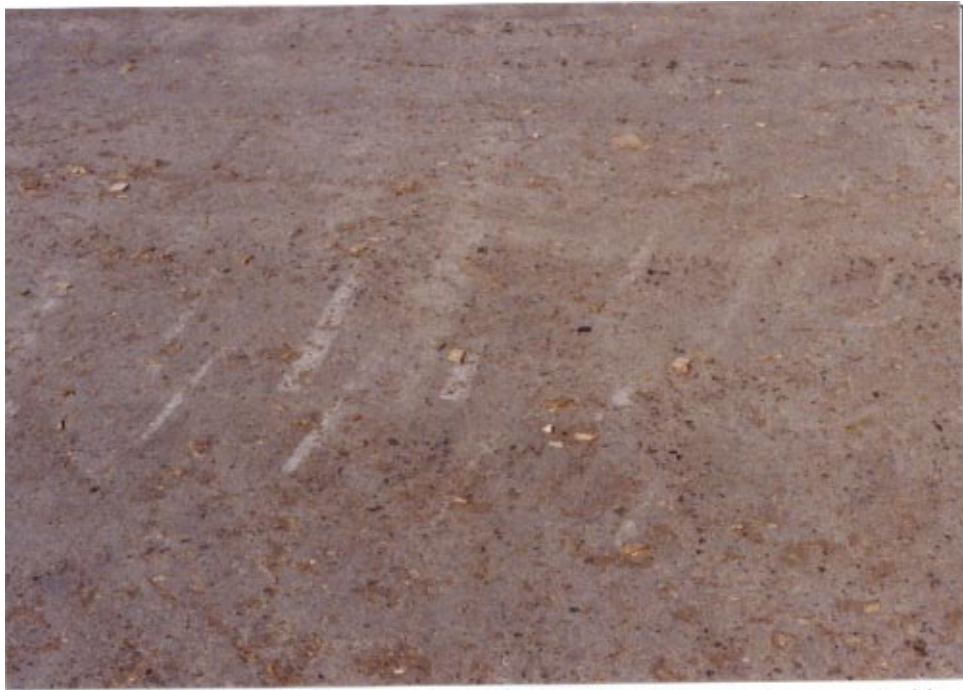
Figure 37 Bulldozer lugged tracks only scuff the surface of the RCC chip storage pile base.

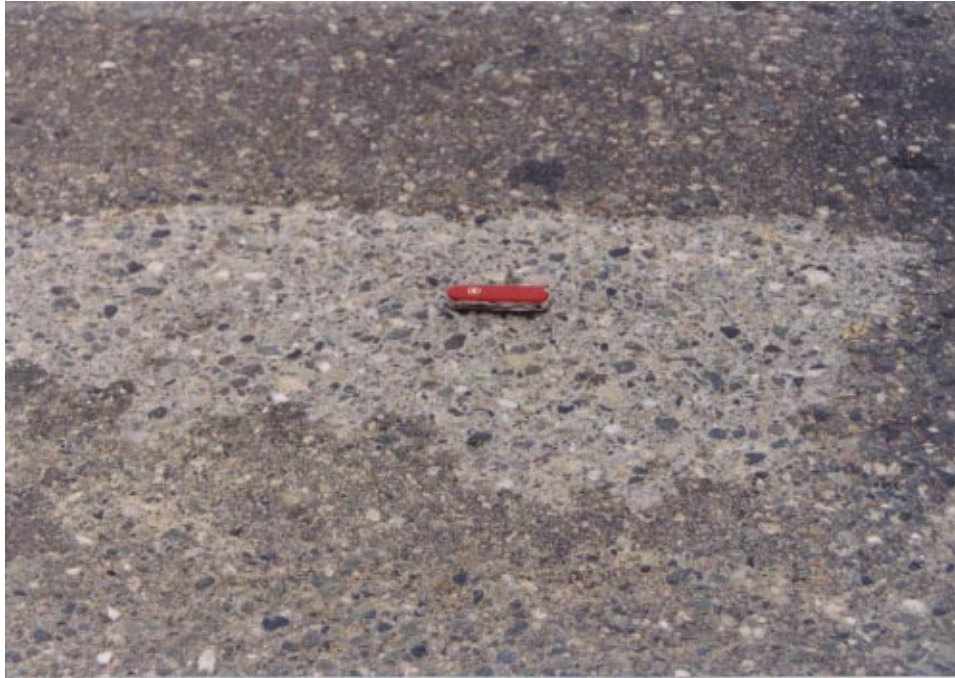
In 1995 a 25 mm (1 in.) asphalt overlay replaced the chip seal surface. At the time of inspection, even this surface is showing traffic wear at the intersection, again exposing a small area of RCC base. Shrinkage cracks have reflected through the asphalt and crack sealing maintenance has been done. There is no evidence of faulting at the transverse shrinkage cracks. Initial concern about performance of the longitudinal centre line joint between the RCC lane and the pre-existing asphalt pavement on the uphill lane has proven to be unfounded. There is no faulting and the longitudinal centerline reflection crack is hairline in appearance. At eleven years of service, this pavement provides strong evidence to support the use of RCC for secondary highways.

Figure 40 RCC surface is exposed again, as the 25 mm (1 in.) asphalt overlay is worn away at the intersection.

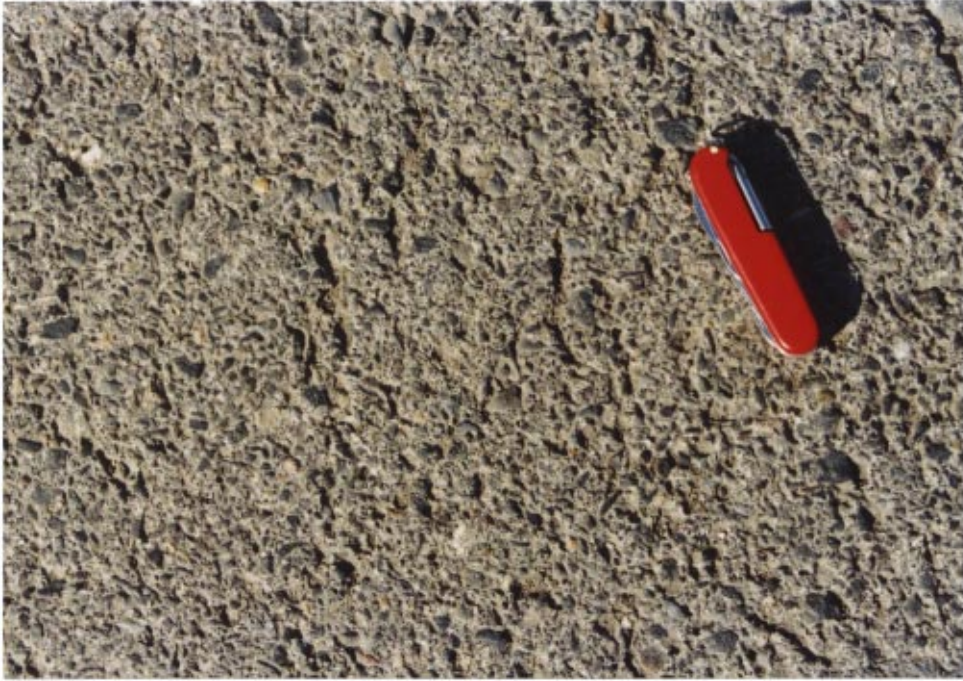
Figure 42 The surface of 99th Ave. shows very little wear after 12 years.

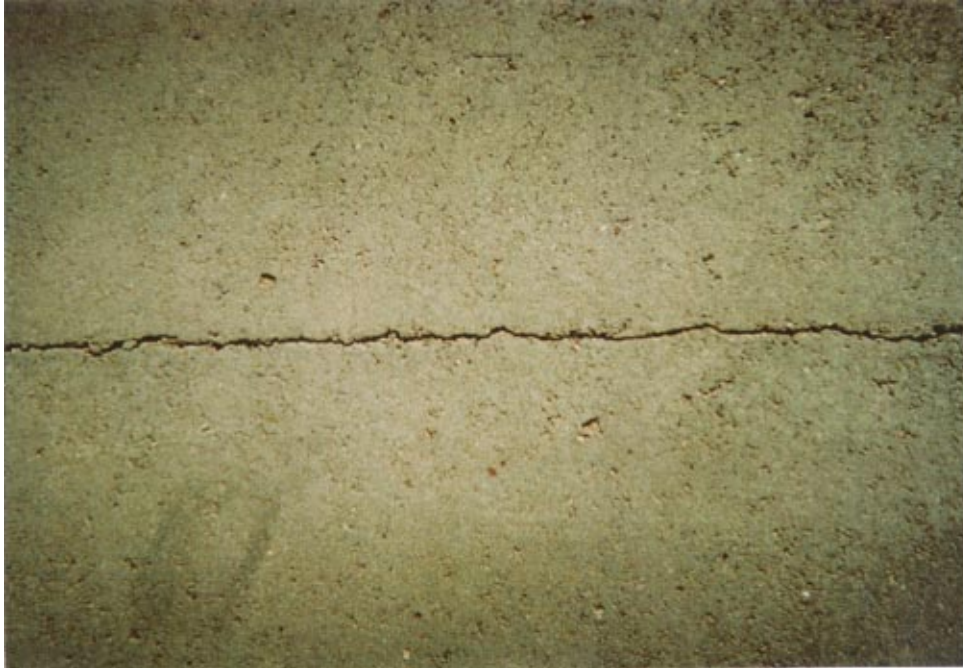
Figure 48 Bighorn Ave. at four years. The surface is in good condition and shrinkage cracks are tight.

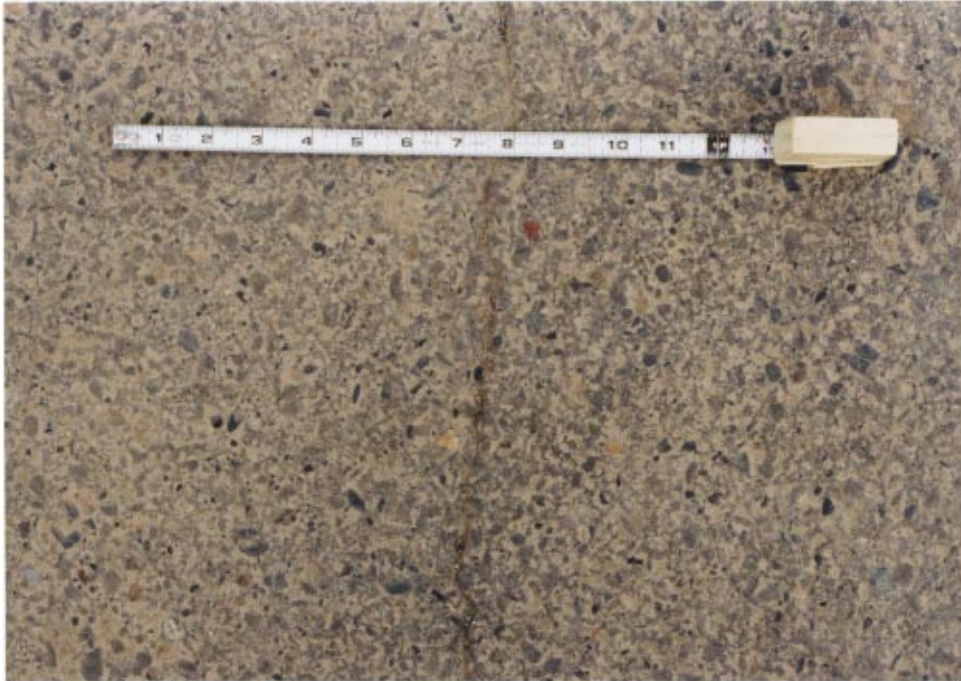
cracks appear near the center line in a few areas. There is no evidence of faulting at any of the cracks. Nor is there any evidence of rutting in the asphalt overlay.

Figure 50 Shrinkage cracks in the RCC base reflect through the asphalt overlay.
