EROSION AND ABRASION RESISTANCE OF SOIL-CEMENT AND ROLLER-COMPACTED CONCRETE

by K. D. Hansen, Schnabel Engineering Associates

Research & Development Bulletin RD126

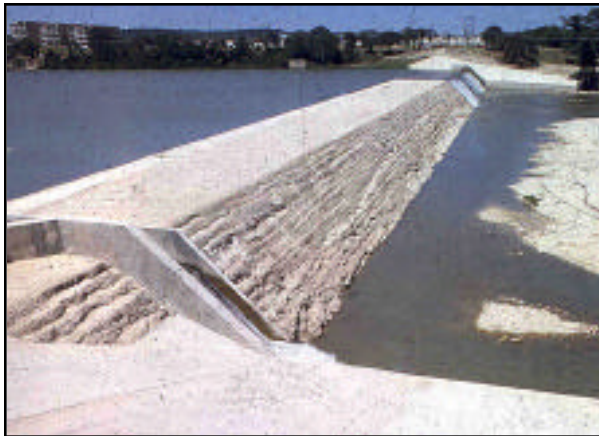
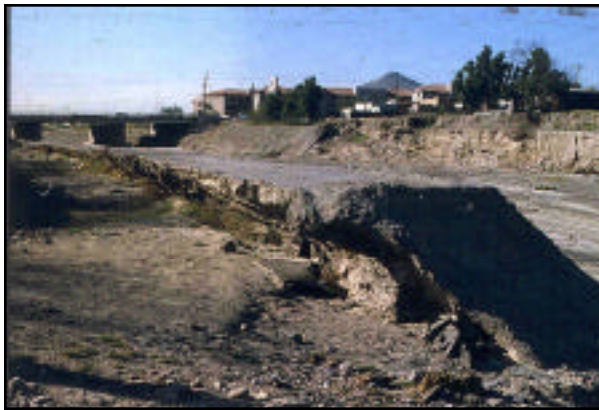
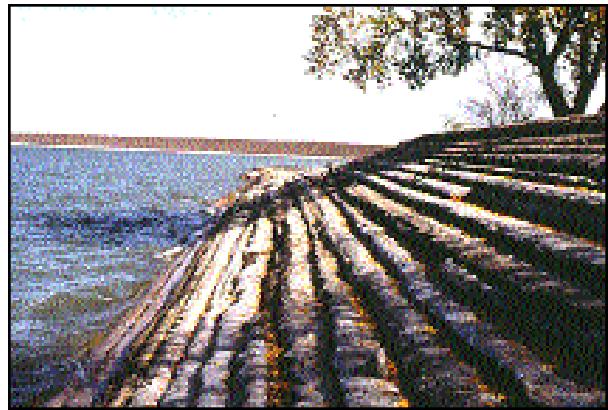
Cover Photos: Top: Photo showing condition of Kerrville RCC Ponding Dam after 1985 overtopping (S#56065)
Bottom left: Soil-cement bank protection after overtopping during 1983 Tucson flood. (S#70037)
Bottomright: Shows condition of Bonny Reservoir soil-cement test section, 49 years after completion (S#70033)

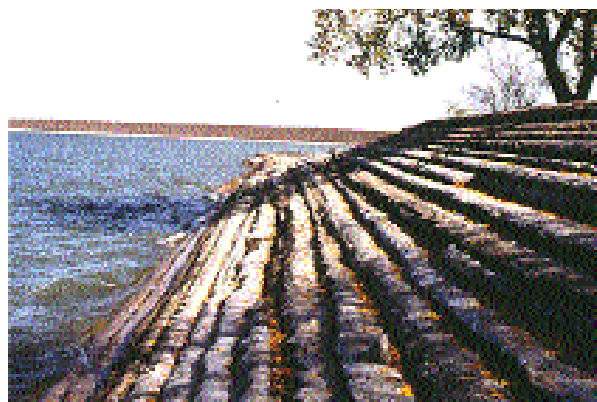
Figure 3. Condition of Bonny Reservoir soil-cement test section, 49 years after completion. (S#70033)

There has been greater erosion at the bottom of the nominal 6-in. (150-mm)-thick lifts due to less cement and less density in this area attributed to the in-place mixing process used to produce the soil-cement. Also, there is little evidence of bonding between successive lifts. This lack of bond together with loss of embankment support due to overtoppings and water outflanking the section has caused some collapse and breakage of single layer soil-cement blocks on both ends of the section. Based on the performance at the Bonny test section it can be concluded that successive lifts of soil-cement should be well bonded if the section is to withstand the forces of high waves with little breakage.

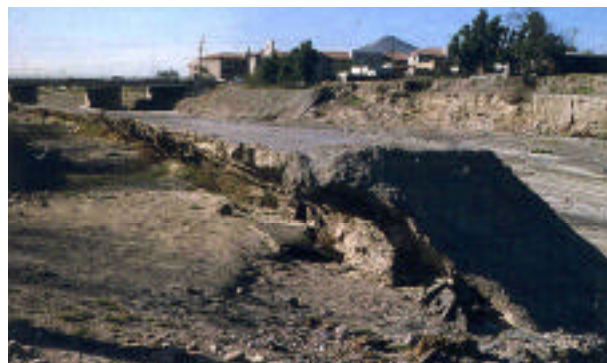
Figure 4. Soil-cement bank protection after overtopping during 1983 Tucson flood. (S#70037)

Soil-cement protected banks withstood the floodwaters very well. The \$4 million Rio Nuevo project on the Santa Cruz and some bank protection along Rillito Creek prevented an estimated \$15 to \$20 million in damage.

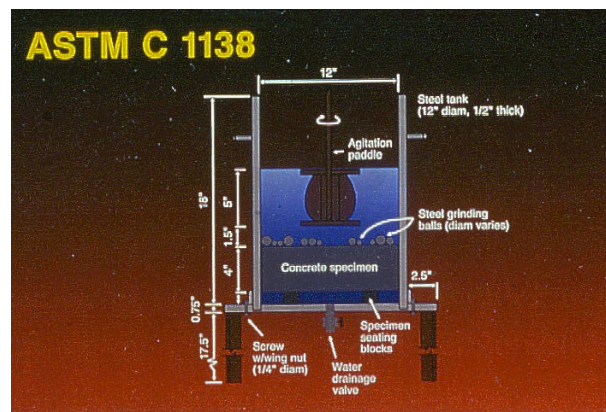
Figure 5. Section of apparatus for underwater abrasion test.

(b) fiber-reinforced concrete, and (c) polymer concrete. However, the apparatus was later used to determine the erosion resistance of both soil-cement and RCC and how these rolled no-slump materials compared with cast conventional concrete.

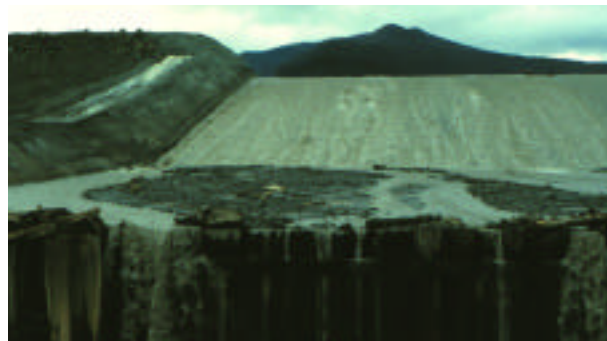
Figure 6. Aftermath of RCC Spillway at North Fork of the Toutle River following 11 months of high velocity flow. Note severe washout behind sheet pile end sill. (S#70046)

In March 1982, another eruption of the volcano brought additional flows down the river causing the embankment to be overtopped and breached on both sides of the spillway. The condition of the spillway surface could now be inspected as water was flowing through the two embankment breaches and not over the spillway. After eleven months of high velocity abrasive flow, about 6 in. (150 mm) of RCC had been eroded down to the steel mesh at one location (see Figure 6). Also, a greater than 6-in. (150-mm) deep abrasion erosion groove occurred at the cold joint in the center of the spillway, as the structure was built in two sections working from the bottom up. The steel reinforcement was also easily abraded in this area.

Because the area had dried out prior to placing the adjacent RCC and had lower density due to lack of edge restraint, it had less strength and therefore less abrasion resistance than the rest of the RCC. Still, the RCC performed quite well, considering the severe conditions to which it was subjected.

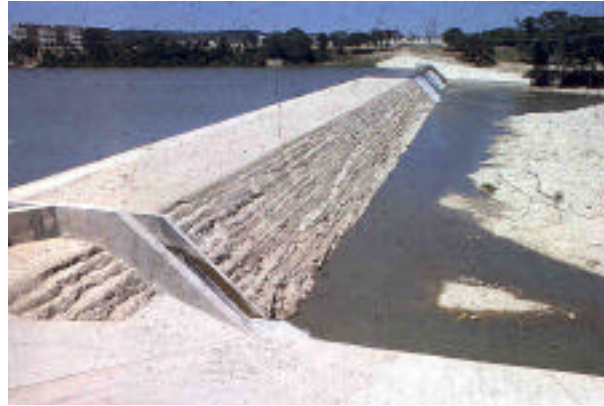
Figure 7. Condition of Kerrville RCC Ponding Dam after 1985 overtopping. (S#56065)

Except for washing away poorly compacted material at the downstream face of the broad-crested weir, there was no noticeable erosion of the RCC (see Figure 7). The maximum flow of 125,000 cfs (3,540 m³/s) was determined to be the 1-in-50-year event.

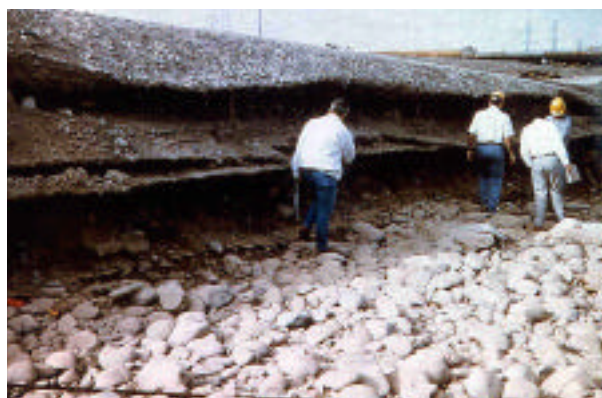
Figure 8. Erosion of cement-stabilized alluvium (CSA) bank protection on south side of Salt River at Tempe, Arizona following 1993 flood.

and cobbles in the river that contributed to abrasion erosion of the banks. Large eroded areas in this area were subsequently repaired by infilling with a lean concrete.

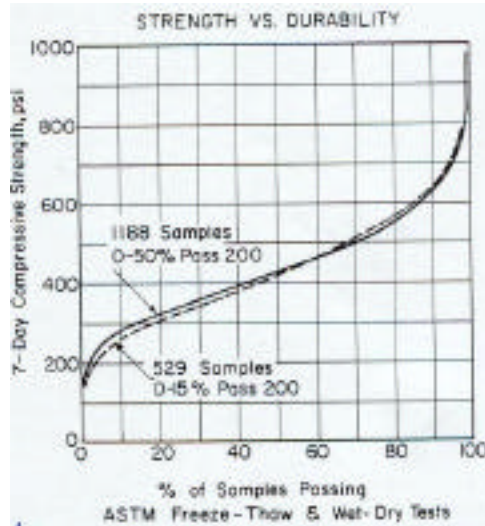
Figure 9. Relationship between a strength and durability of soil-cement (PCA 1992).
